Manhole Inspection Summary

Manhole # S07WW1010MH

Insp Date: **9/13/06 10:22 AM**

Location Address: **5704 KEY AVE**

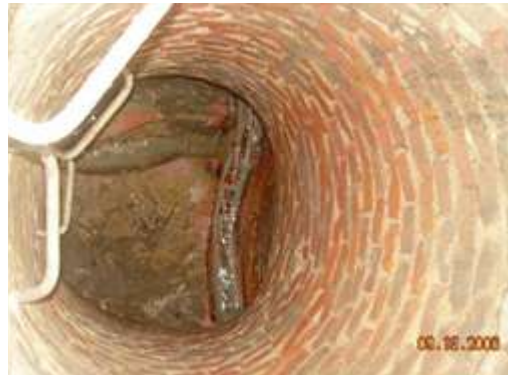
Top View

Evidence of surcharge - Bench debris.

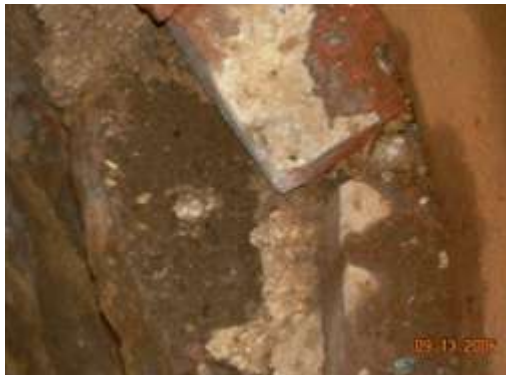
Defect

Frame leaks. Adjustment deterioration, loose brick, and infiltration.

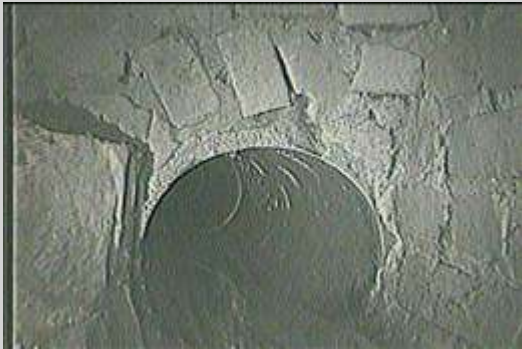
10 in. Circular Gravity Sewer Pipe Out @ 12 O'Clock

Infiltration: **Evidence** Pipe Seal Cond: **Cracked**
